How Hubble Space Telescope failed

--Synopsis of Hubble Space Telescope Optical Systems Failure Report

OPTI 521 synopsis by Tianquan Su

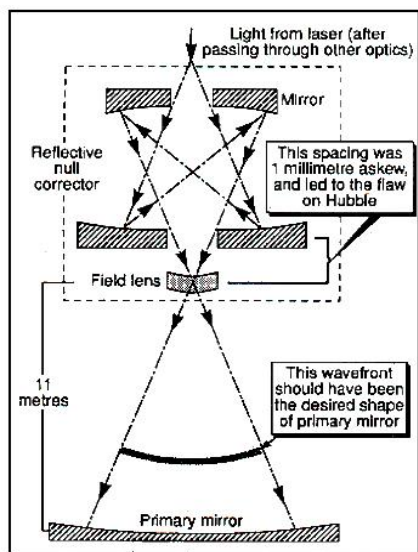
Figure 2: Reflective Null Corrector

As shown in Figure 2 and Figure 3, the RNC consists of two spherical mirrors, the larger of which has a clear aperture of < 10 in. (25.4 cm), and a small refraction field lens whose clear aperture is < 1 in. (2.54 cm).

field lens. This measurement showed that the field lens was about 1.3 mm too far from the lower mirror. When the field lens position error is taken into account and applied in correcting the data taken with the RNC, it results in a mirror shape that would account for most of the error observed in the HST images.

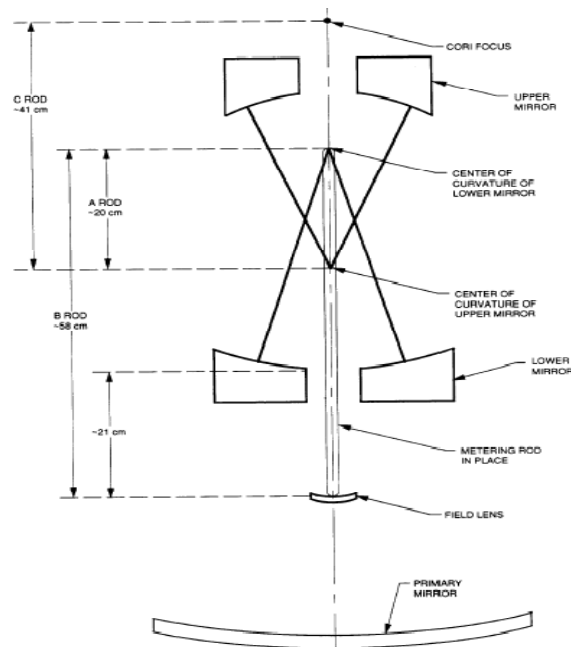
Figure 4: Position of metering rod used to spacing optical elements in RNC

The RNC used to measure the HST primary mirror was modified from the one used on a smaller mirror prototype. This modification required adding a new field lens and respacing the optical elements. Figure 4 shows the positions of the metering rods used to set the optics.

The metering rods were made of Invar (a metal with a small temperature expansion coefficient). The ends of the metering rods were rounded and polished for using an interferometer to measure the position. This procedure involved auto-reflecting a focused beam of light off the end of a rod and observing an interference pattern from the beam that came back on itself. Centering the light beam on the rod end was essential for the measurement. To prevent the metering rod from being misaligned laterally with respect to the interferometer axis, P-E decided to attach "field caps" to one end of the rod (Figure 5). The field caps were fitted over the rod ends and had a small aperture in the center to ensure centering of the rod on the beam.

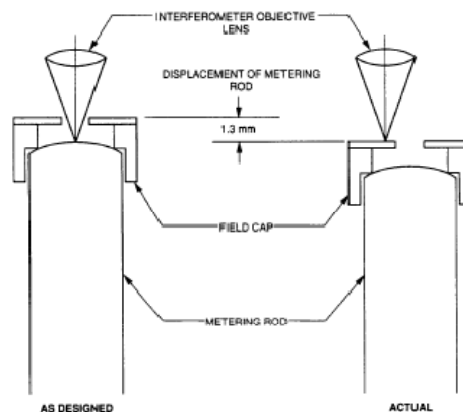
Figure 5: Displacement due to the interferometer focusing on the field cap instead of the metering rod

The top surface of the field cap was covered with nonreflecting material; however, some of this material had broken away from a small area around the field cap aperture. It appears that the operator obtained reflection from the field cap where the nonreflecting material was absent, rather than the rod end, causing the 1.3 mm misspacing. A test with the equipment showed that it was quite easy, even probable, to make this error with the configuration used. The final location of the field lens was then set with the addition of the spacers. As a result, the field lens was about 1.3 mm too far from its correct position relative to the lower mirror.

Large projects usually have considerable quantities of procedure steps. Errors in early step can cause huge damage to the whole project. The investigation clearly showed that the method used to spacing the RNC could be improved. Reliance on a single test method is a process which is clearly vulnerable to simple error. Errors were shown during the fabrication and testing procedure, but were ridiculously ignored by P-E. This indicates that efficient communication within the group is needed. Moreover, tight budget, both timely and economically, prevented the system from being tested fully and independently. After all, competitive, organizational, cost, and schedule pressures were all factors in limiting full exposure of all the test information to qualified reviewers.
