Repairing stress induced cracks in the Keck primary mirror segments

Dennis McBride, John S. Hudek, Sergey Pantelev

W.M. Keck Observatory, 65-1120 Mamalahoa Hwy., Kamuela HI, USA 96743

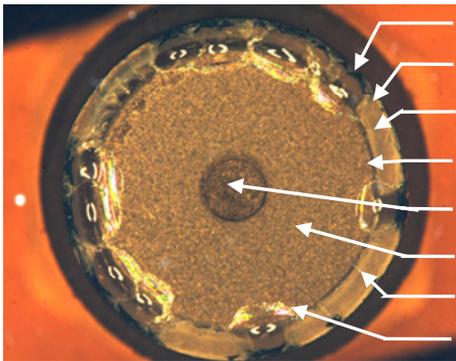
Figure 7

Examples from the photo survey of axial insert cracks and how they develop are shown in Figures 7, 8, and 9. The view is looking through the glass from the front surface towards the bottom of the axial insert.

- Glass cracks start at the fillet and grow inward
- Glass fillet radius = .04"
- Unsupported adhesive generates high stress when cold
- Edge of axial insert
- Adhesive nub spacer
- Air bubbles
- Cracks in adhesive due to aging
- Glass cracks grow conchoidally

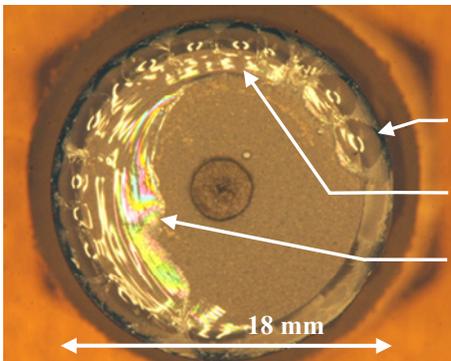
Figure 8

- Cracks start here
- Cracks merge as they grow
- Eventually cracks breach the bottom of the insert

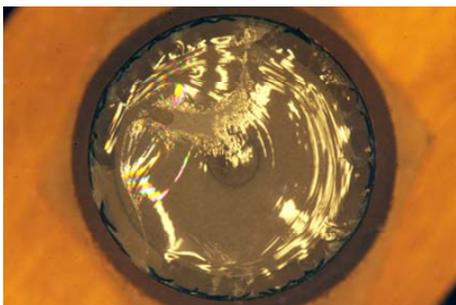
Figure 9

Complete failure

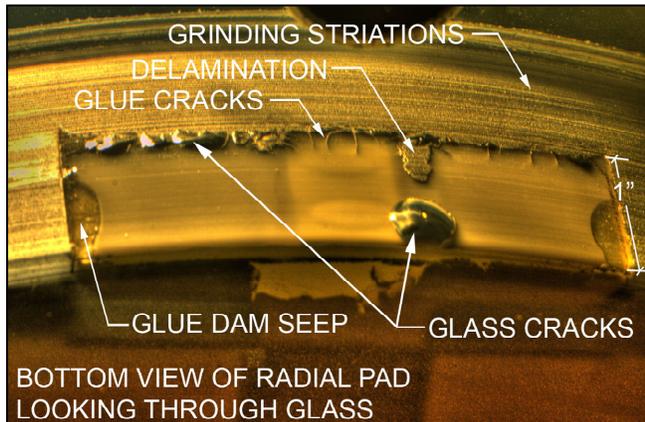
Typical radial pad cracks are shown in Figures 10 and 11.

The low viscosity epoxy adhesive EA-9313 was injected into two slots in the face of the pad until adhesive flowed out of the top edge of the pad. This left a thick fillet of epoxy along the top edge. The fillet generates high stresses in the glass when cooled. Also, epoxy remains in the injection slots. The large round bubble crack seen in Figure 10 is at the bottom of one of the slots. The crack in this location is commonly seen on the radial pads. Many of the radial pad cracks appear to be self-terminating. However, the crack seen in Figure 11 extends into the glass and may propagate further.

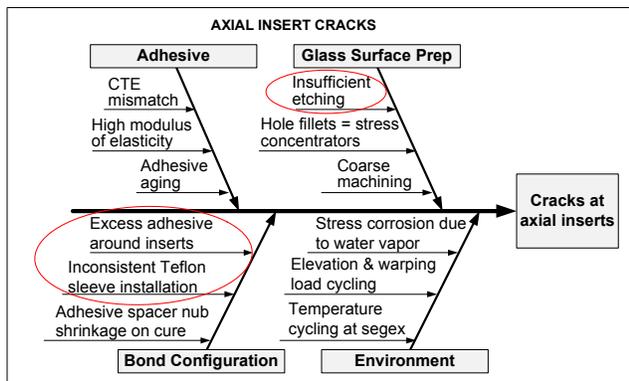
Figure 12

Several factors that contribute to the development of cracks have been identified. These are summarized in Figures 12 and 13, and the most significant are discussed below.

Two key elements for both axial inserts and radial pads are glass surface preparation and the excess unsupported adhesive around the bonds. Subsurface damage (SSD) left from machining is the starting point for crack growth. Schott has shown that the surface strength of Zerodur can be increased greatly by etching sufficiently to remove SSD^{7,8}. In general, to produce a high strength surface for bonding, a minimum amount of material must be removed by etching.⁹ Mirror segment specifications called for “Acid etching to remove stresses.” However, there is no indication how much material was to be removed by etching, or what the final surface profile should be.

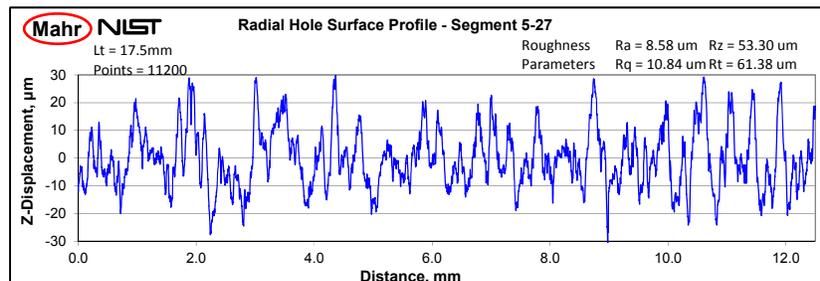
Figure 14

For the central radial hole, machining is seen to be very coarse, and there are striations left by the cutting tool. Measurements of a typical surface profile with a Mahr PS1 profilometer, and processed by the NIST Surface Metrology System¹⁰ shows the very rough surface in Figure 14. The mean surface roughness parameter $R_a = 8.6 \mu\text{m}$. By comparison, Zerodur ground with 240 grit diamond (FEPA D64) typically has a surface roughness parameter R_a less than $2 \mu\text{m}$ (depending on tool speed and load). Finite element studies have shown that the striations produce stress concentrators that increase stresses by a factor of up to three.

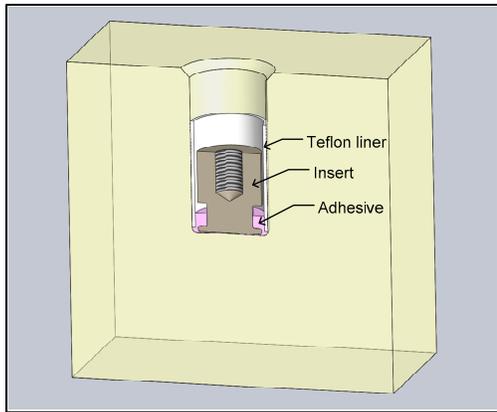
Figure 15

The original axial inserts were bonded at the bottoms of the holes, as in Figure 15. The procedure was to insert a Teflon sleeve into the hole, pour adhesive into the hole, and then push the insert into place. A previously cured nub of adhesive machined to 0.25mm thickness served as a spacer. The Teflon sleeve was removed after the adhesive cured. This method left a layer of unsupported adhesive about 0.5mm to 1 mm thick surrounding the insert which intersects the glass at the fillet, as in Figure 16. The thickness of the adhesive is determined by how far the Teflon sleeve was pushed into the hole. The coefficient of thermal expansion (CTE) of the adhesive is about 83 ppm/°C.

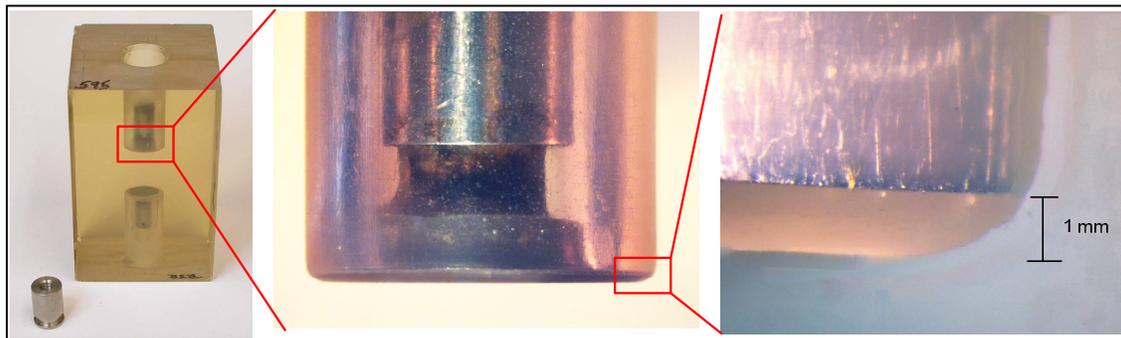
Figure 17 shows a close up of an insert installed into a test block that was made at the time the original segments were fabricated. The thick layer of unsupported adhesive is seen in the right side photo. Notice that the edge of the adhesive meets the glass approximately at the center of the glass fillet, which acts as a stress concentrator.

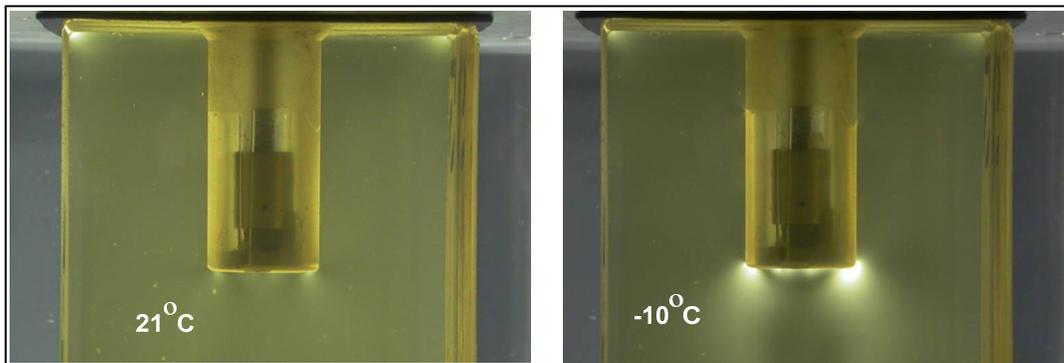
Figure 18

Seen through a polariscope in Figure 18, the high stress generated at low temperature is evident.
