Contamination-induced degradation of optics exposed to the Hubble Space Telescope interior

June L. Tveekrem, Douglas B. Leviton, Charles M. Fleetwood, and Lee D. Feinberg

NASA Goddard Space Flight Center
Greenbelt, MD 20771

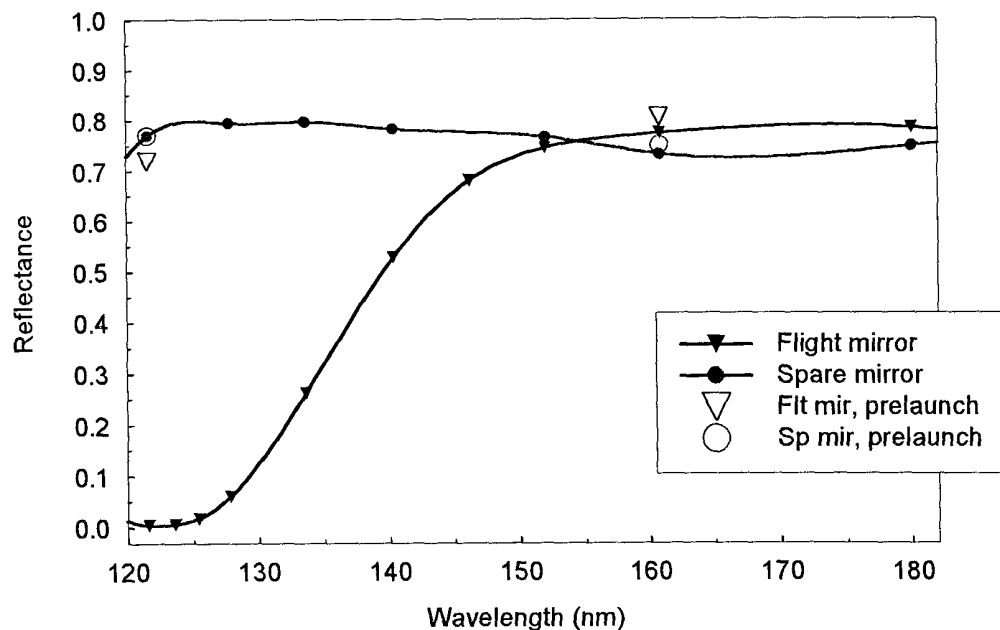
Figure 1. UV Reflectance at Normal Incidence
Flight and Spare Pickoff Mirrors

The results for the far UV are shown in Figures 1-3. In addition to the usual measurements at normal incidence, measurements at a 45° angle of incidence were also performed because the pickoff mirror was used at a 45° angle during the HST mission. The flight pickoff mirror showed a dramatic loss of reflectance in the far ultraviolet compared to the spare pickoff mirror and compared to preflight measurements of both the flight and spare mirrors. No significant reflectance change was seen in the visible and near UV.

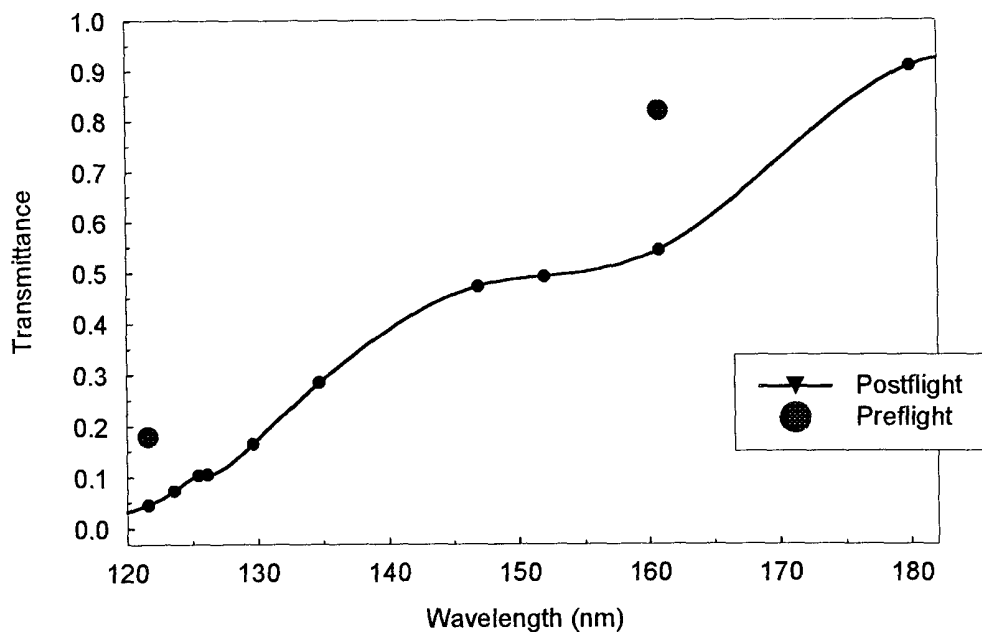
Figure 3. UV Transmittance of Aperture Window

The aperture window showed a transmittance loss in the ultraviolet. Some transmittance roll-off was expected for a thick magnesium fluoride window; however additional degradation was apparent compared to the preflight data.

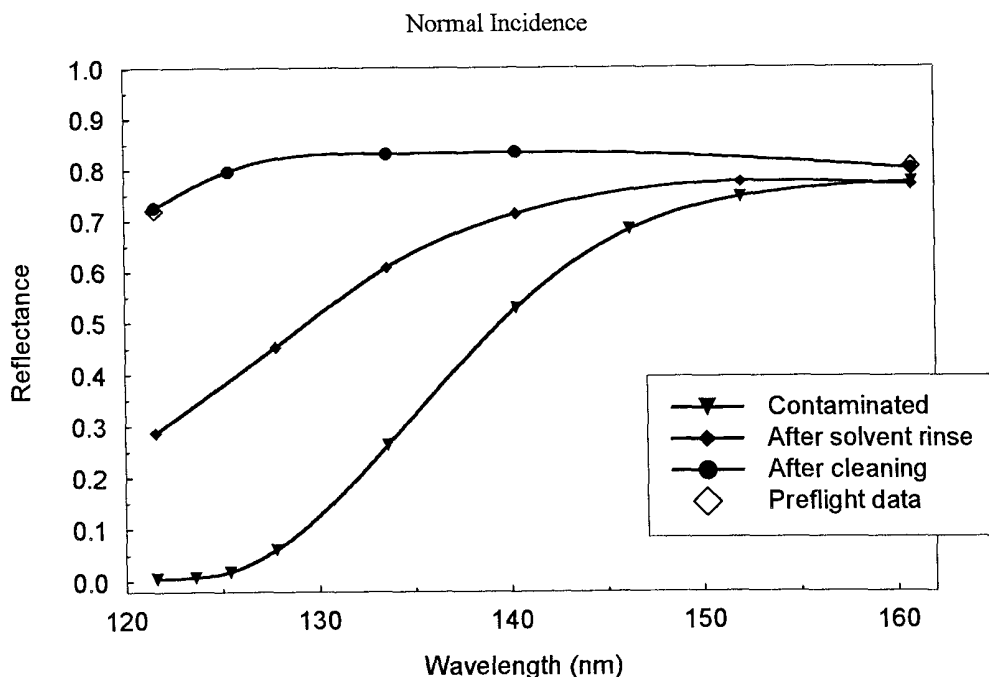
Figure 4. Pickoff Mirror Reflectance Restoration

During the surface chemical analyses, it was noted that the degraded UV reflectance of the pickoff mirror was partially restored by solvent rinsing. In the process of performing GC/MS, portions of the aperture window and pickoff mirror had been rinsed with methylene chloride. Their reflectance and transmittance were remeasured after this solvent rinsing. The aperture window results were inconclusive, but the pickoff mirror reflectance was partially restored (see Figure 4.) Furthermore, the contamination on the aperture window was measured by XPS before and after the methylene chloride rinse. By comparing the relative strengths of the XPS peaks, it was estimated that 2/3 of the contamination layer was removed by the solvent.

After all the examinations and chemical analyses were completed, a final test was done to determine whether the UV reflectance of the pickoff mirror could be entirely restored by cleaning. If it could, this would conclusively demonstrate that the reflectance degradation was due entirely to contamination, not to a combination of contamination and coating damage. First, the reflectance of the pickoff mirror was remeasured at 3 different locations on the mirror. Then the entire mirror was cleaned using the following procedure: The mirror was immersed in a solution of Alconox and water. A clean piece of cheesecloth was also immersed in the solution. With the mirror and the cheesecloth still under water, the cloth was laid on top of the mirror and dragged/rubbed very gently across the surface several times. Because magnesium fluoride coatings are easily scratched, the pressure applied was not much more than the weight of the cheesecloth. The mirror was then rinsed continuously for about 1 minute with a steady stream of distilled water. The mirror was rinsed again continuously for about 1 minute with a steady stream of distilled acetone. Finally, the mirror was inspected to ensure that there was no visible solvent residue or dust left behind on the surface. The reflectance of the cleaned mirror was then measured at the same 3 spots. The preflight reflectance was completely restored, as shown in Figure 4.
