How Hubble Space Telescope failed

--Synopsis of Hubble Space Telescope Optical Systems Failure Report

OPTI 521 synopsis by Tianquan Su

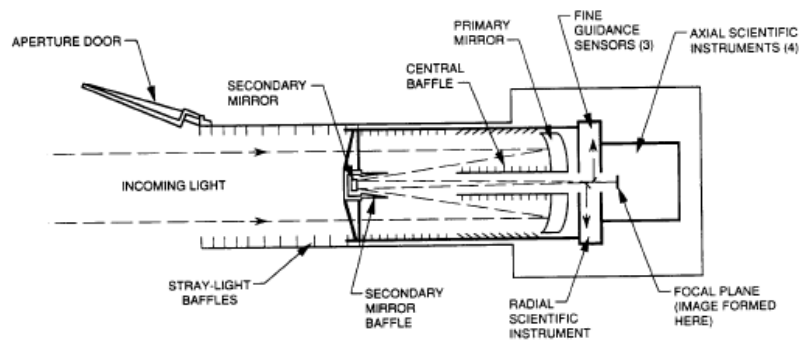
Figure 1: Optical Telescope Assembly

The Optical Telescope Assembly (OTA) in The Hubble Space Telescope is a two-mirror reflecting telescope with a focal ratio of $f/24$. This kind of telescope is generally referred to as Cassegrain telescope, but the mirrors in the OTA are slightly more aspheric than in the normal Cassegrain type. The primary mirror in the OTA (the one in which the error exists) is a 2.4-m diameter concave hyperboloid. The 0.3-m diameter secondary mirror is a convex hyperboloid.
