Repairing stress induced cracks in the Keck primary mirror segments

Dennis McBride, John S. Hudek, Sergey Pantelev

W.M. Keck Observatory, 65-1120 Mamalahoa Hwy., Kamuela HI, USA 96743

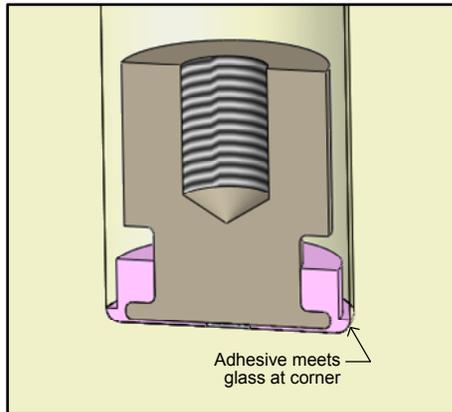
Figure 16

The original axial inserts were bonded at the bottoms of the holes, as in Figure 15. The procedure was to insert a Teflon sleeve into the hole, pour adhesive into the hole, and then push the insert into place. A previously cured nub of adhesive machined to 0.25mm thickness served as a spacer. The Teflon sleeve was removed after the adhesive cured. This method left a layer of unsupported adhesive about 0.5mm to 1 mm thick surrounding the insert which intersects the glass at the fillet, as in Figure 16. The thickness of the adhesive is determined by how far the Teflon sleeve was pushed into the hole. The coefficient of thermal expansion (CTE) of the adhesive is about 83 ppm/°C.
